QUINQUENNIAL INSPECTION

CHURCH OF ALL HALLOWS, RINGMORE, DEVON

DATE OF INSPECTION 22ND SEPTEMBER 1999

MSW Conservation
Chartered Architects & Surveyors
PO Box 27
Lifton
Devon PL16 0YD

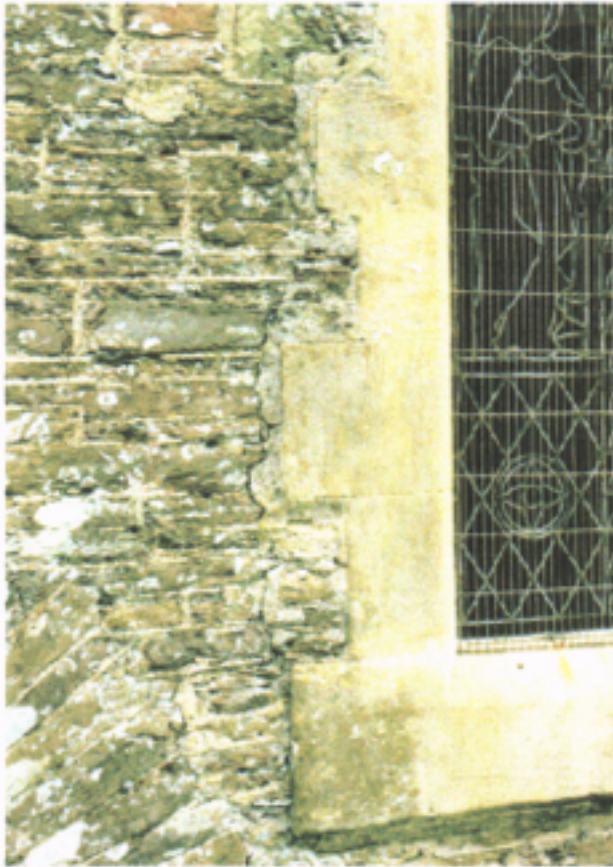
Of rubble construction the south wall shows deterioration in the pointing, stonework is laminating in several areas. There are a number of cracks apparent mostly around windows and to the entry door to Chancel. It is understood rainwater has penetrated into the church through the windows on the south elevation. Raking out the defective mortar around the cracks adjacent to the windows and indeed the entry door is recommended. In addition there are voids in the masonry just under the eaves that require urgent attention. See photographic illustrations on pages 9 and 11

Top left: One of the windows in the south wall

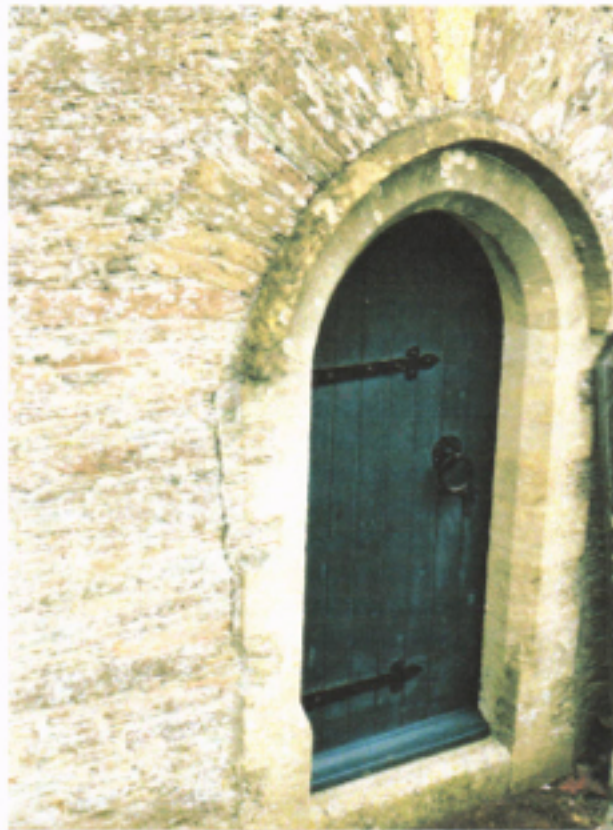
There is a vertical crack in the return wall, between the Chancel and Nave, that has previously been repaired. The repair mortar is separating and may be defective. It is recommended the defective mortar is raked out and a new repair made.

Bottom left: Vertical crack in wall adjacent to south door

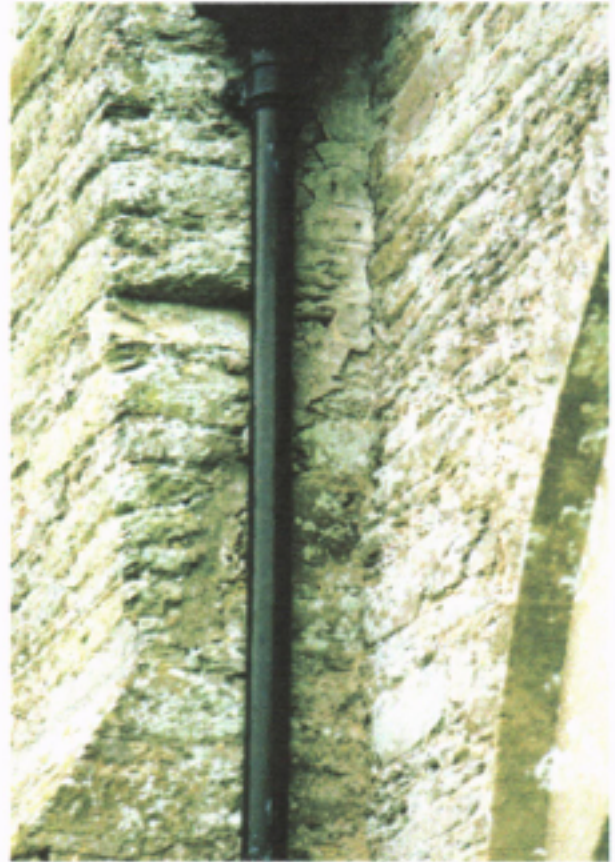
Above: Vertical crack in buttress to south wall

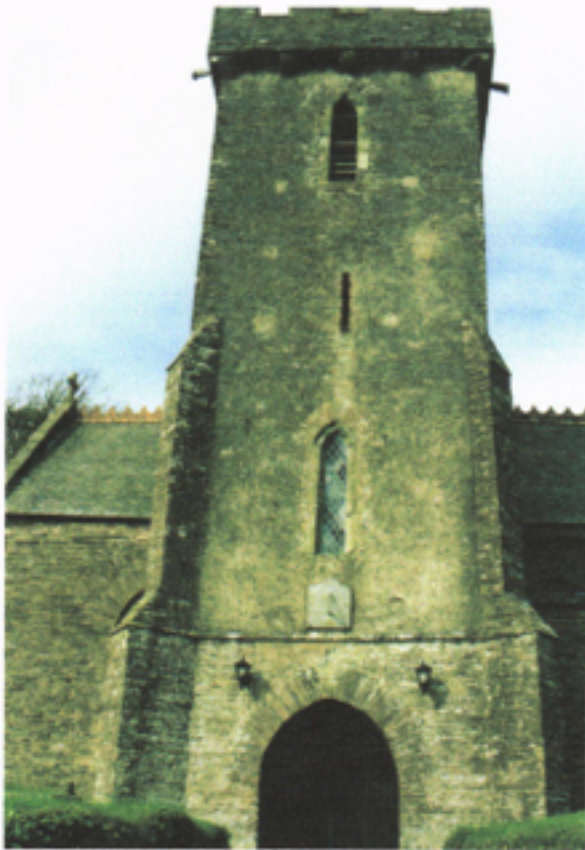
The rubble masonry to the tower appears in good condition except for the areas where weathering has eroded the rendered surface. Re-pointing of the stonework dressing the lancet window and repairs to the nid slit are required. See photographic illustrations on page 10.

Top left: Tower, South face

Remove vegetation from slit.

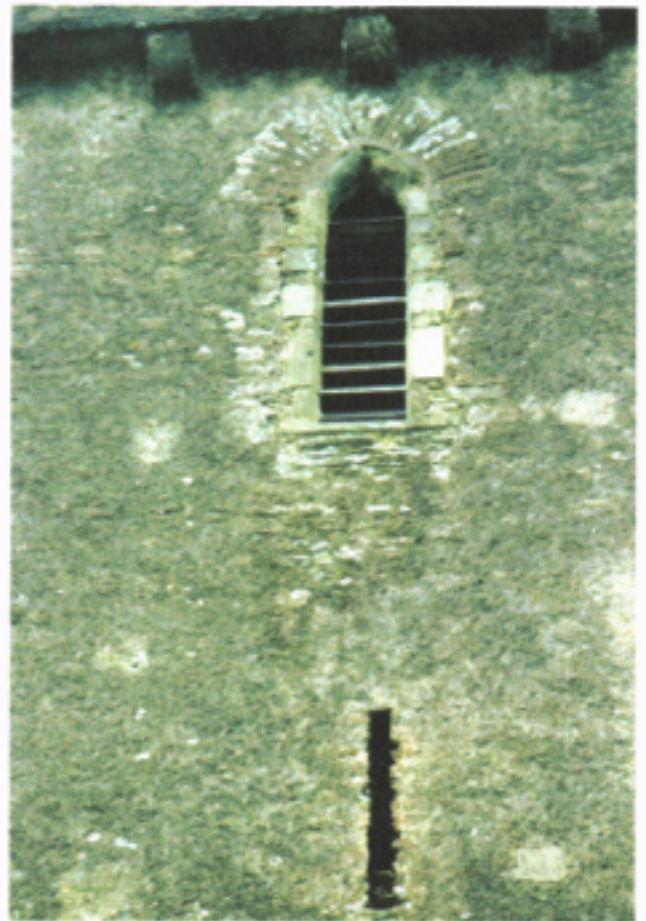
Bottom left: Tower, South face, and lower lancet

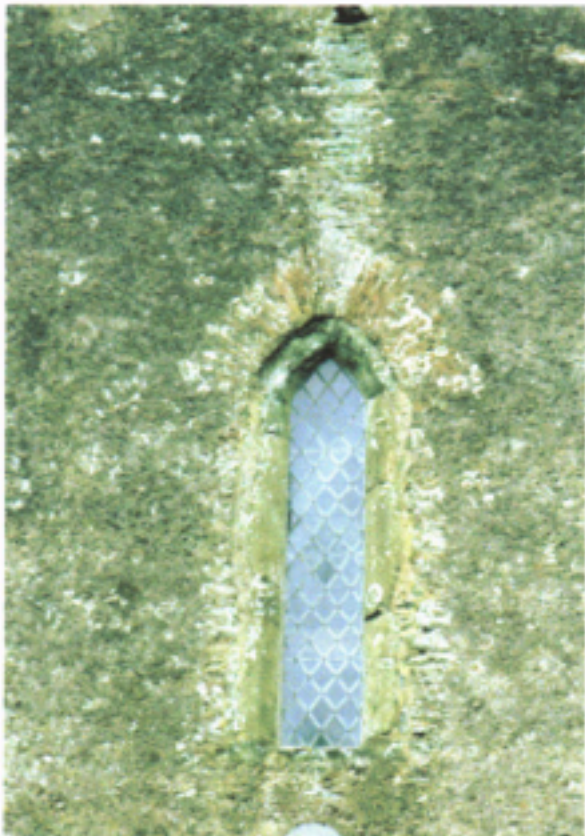
Above: Tower, South face, lancet to bell chamber and slit opening under

Window dressing has suffer from some erosion over time. Repairs should be considered to minimise further erosion damage. Mortar has washed out from joints. Re-point is suggested to minimise further erosion of stonework.

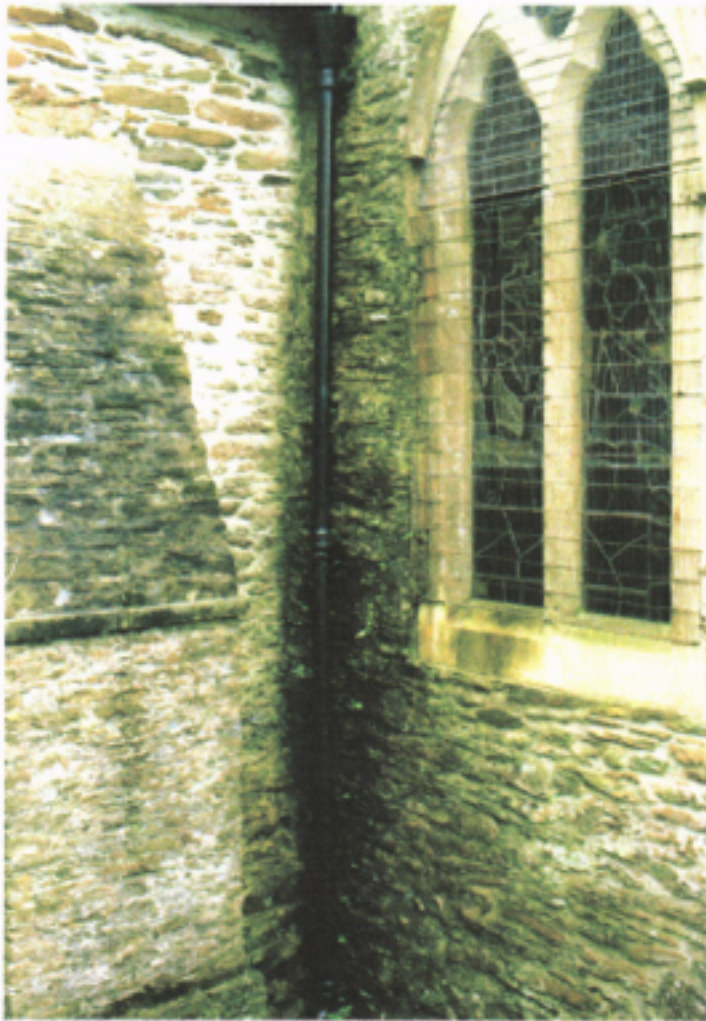
Masonry is generally sound but it is clear the rainwater down pipe/hopper/gutter is not adequately handling the volume of rainwater from the North Transept. The wall has discoloured as can be seen from the photographic illustration on page 11. The operation of the rainwater disposal system should be checked as described.

Top left: Junction of North wall & North Transept showing effects of damp and vegetation growing in wall

Remove vegetation from masonry.

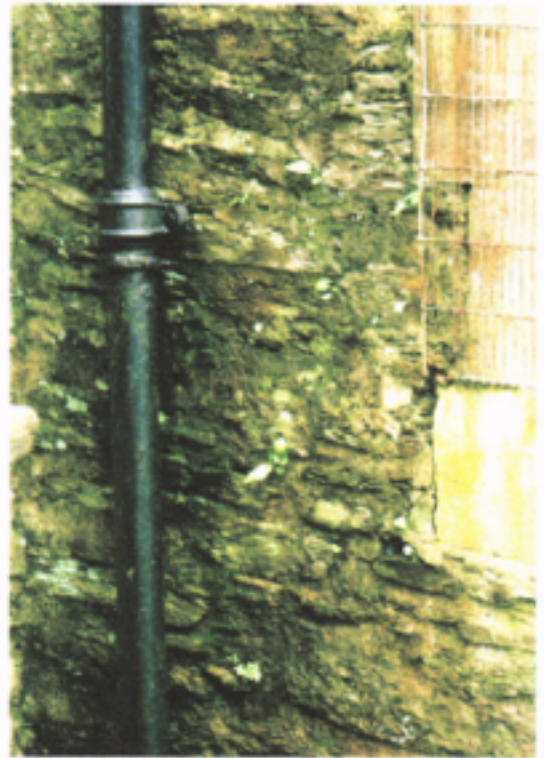
There is some deterioration in the pointing to the stone dressing to north window please see the photographic illustration on page 11.

Top right: Closer view of defective mortar eroded by damp conditions

Re-point masonry beneath gutter where pointing has decayed.

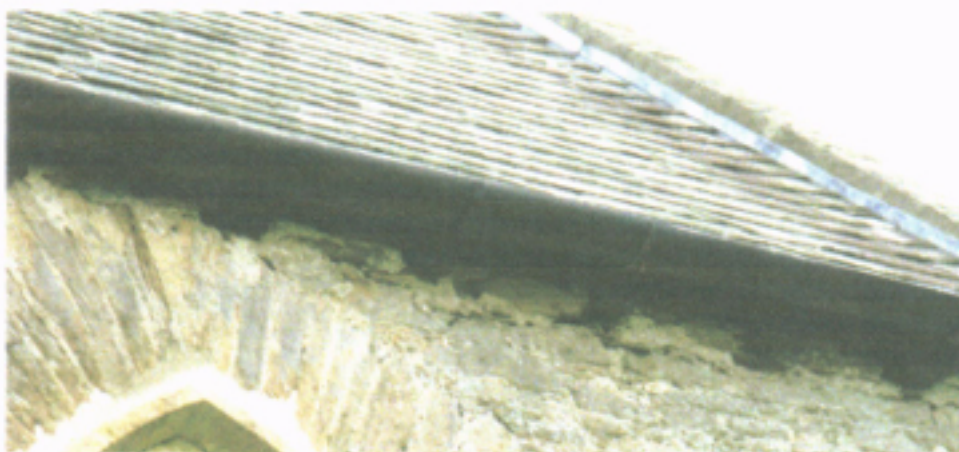
Left: South wall, Voids in masonry below gutter

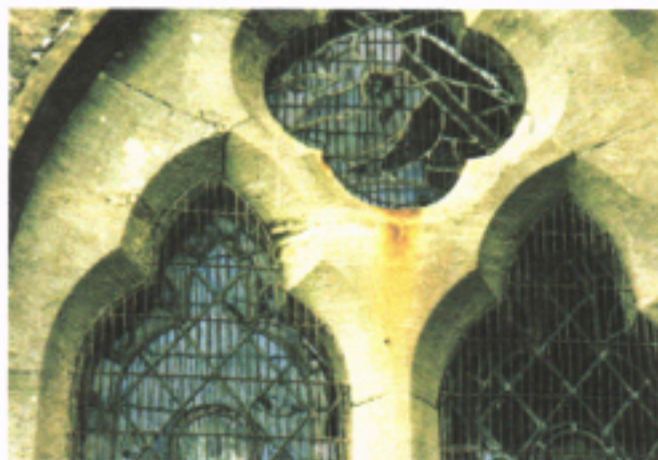
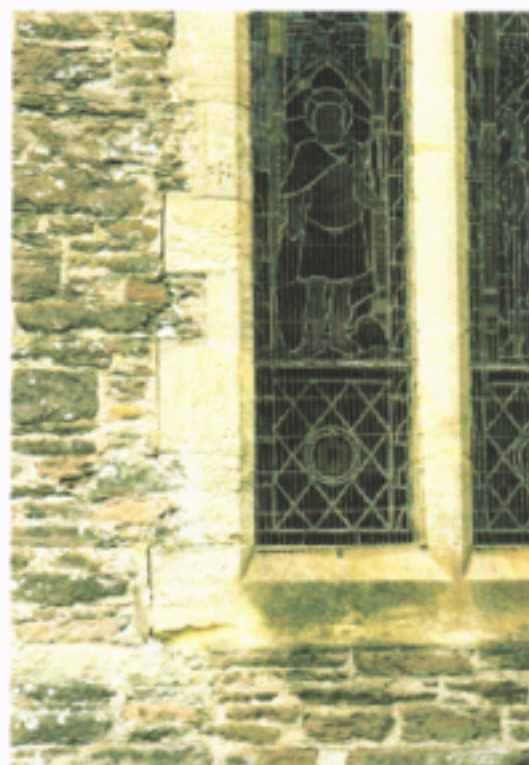
South wall - Nave West End

This window appears to have settled slightly. Bath stone dressing has suffered some erosion in parts. Please see photographic illustration to the right and below . Water penetration to the interior of the church noted. Pointing between window dressing and masonry wall requires attention see south wall re-pointing page 6. Window grille rusting and may need replacing.

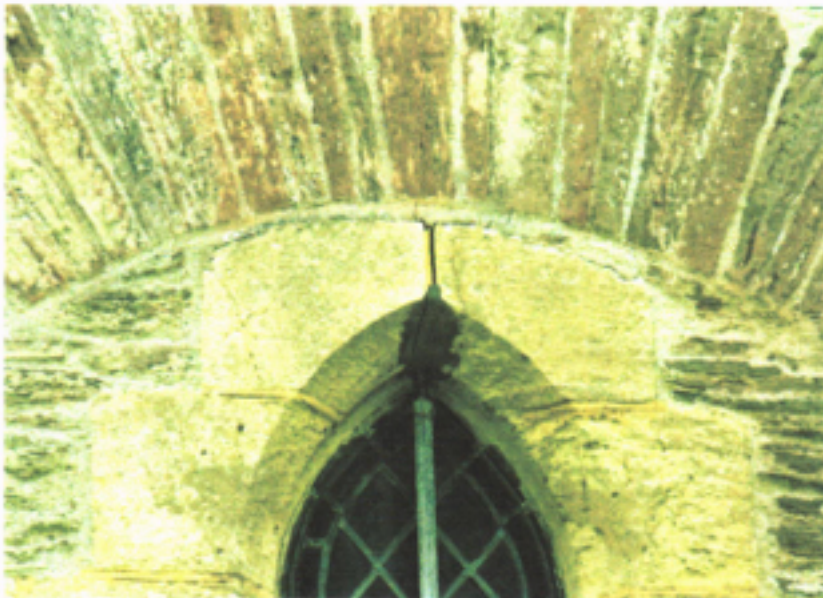
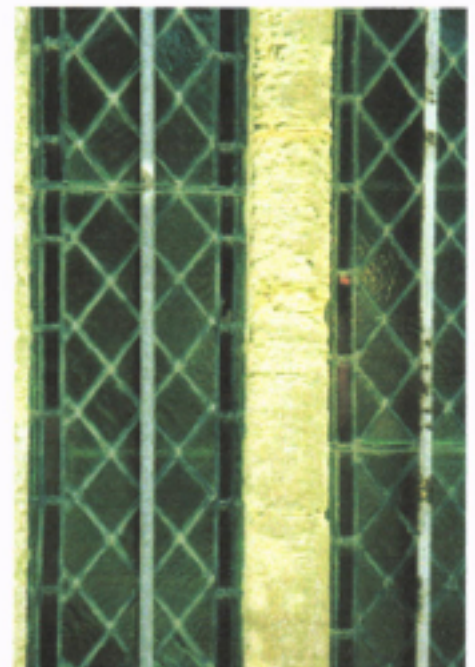
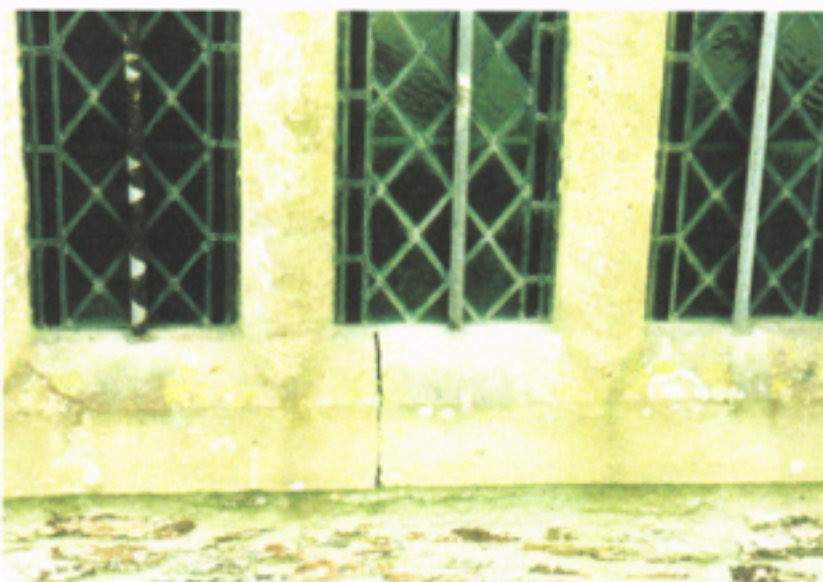
North Transept - North wall

This window appears to have settled slightly. Bath stone dressing has suffered some erosion in parts. Please see photographic illustration below. Water penetration to the interior of the church noted. Pointing between window dressing and masonry wall requires attention. Window bars appear to have assisted to damage to the window dressing. Consideration to be given to replacing the window bars with non-ferrous type.

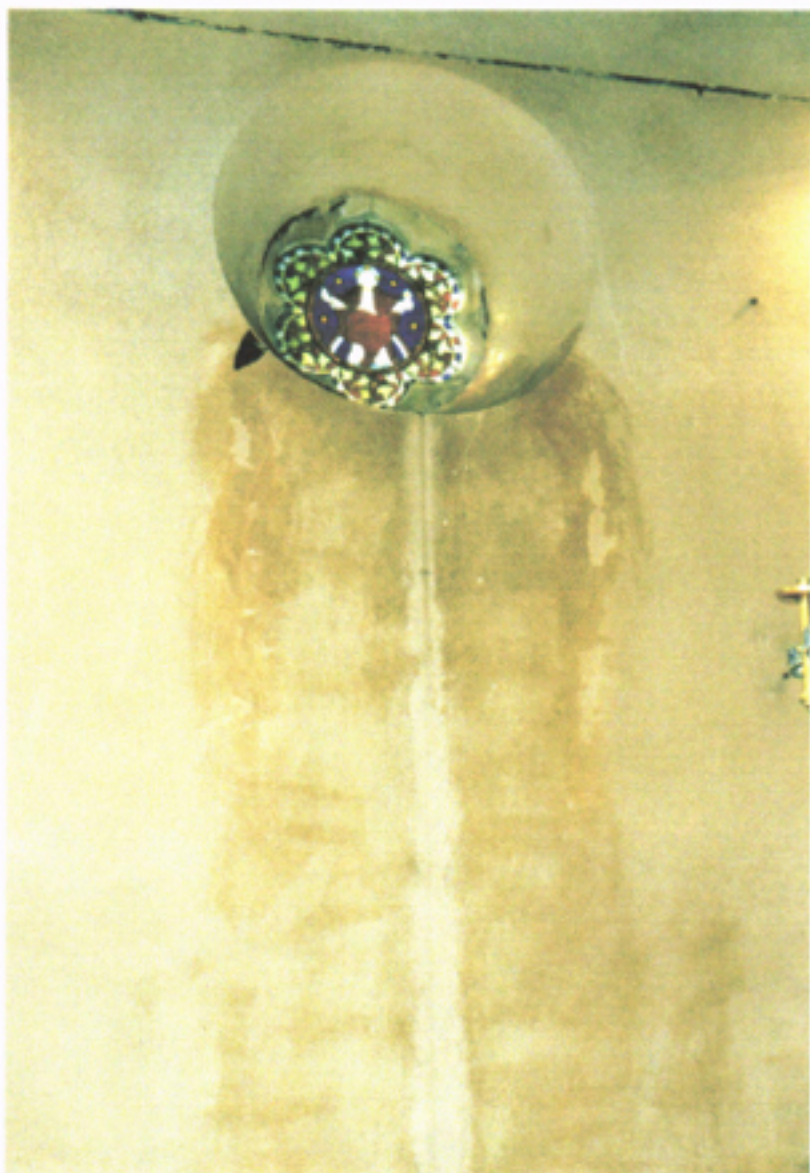
The rendering to the west wall has indications of damage. This damage appears to result from the ingress of water. See photographic illustration on page 18. As indicated in the section on windows an outer glass or Perspex panel has been added, presumably to protect the rose window. A mastic sealing compound appears to have been applied to the edge of this panel, probably in an attempt to minimise the entry of rainwater. Water penetration is apparent however. It is recommended the panel be removed to enable an inspection of the rose window to be made in order to ascertain what remedial work may be required.

West wall rose window showing effect of water penetration on plasterwork
