## **All Hallows Church, Ringmore, Devon**

**Survey of the Wall Painting on the West Face of the  
Chancel arch  
and polychrome on the pulpit and screen**

**October 2003**

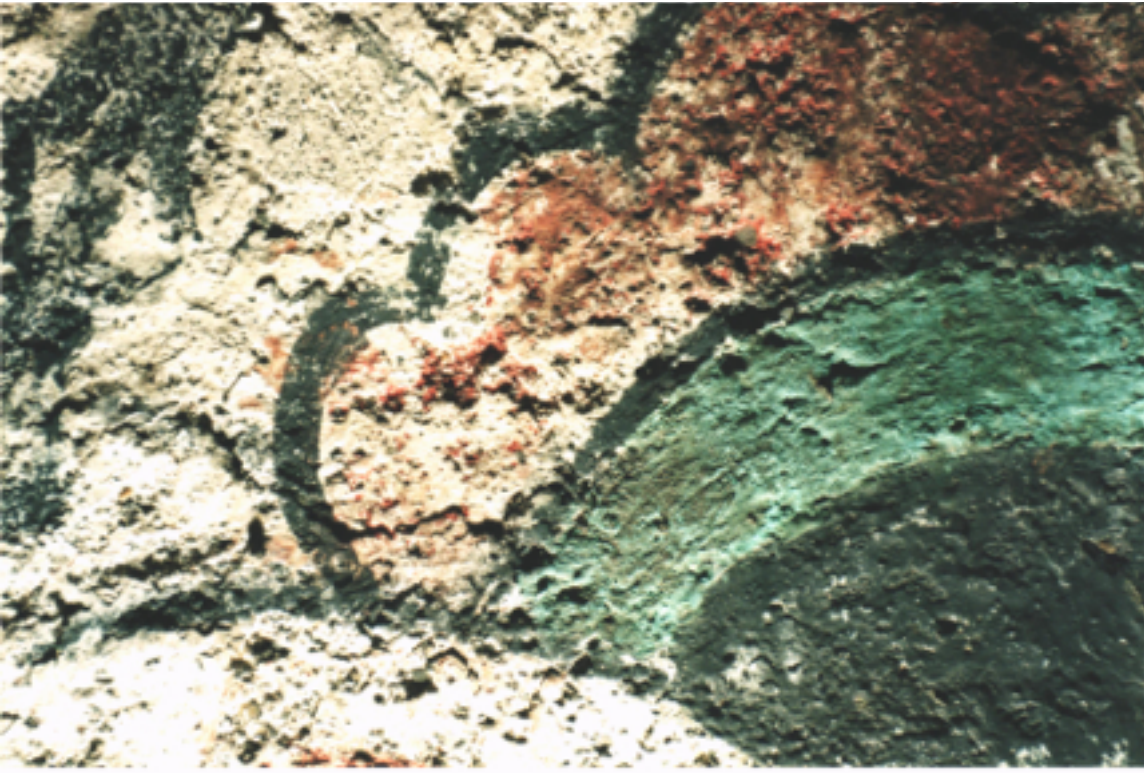
Some later fills have been applied at the lower edge of the painting, in the position where the rood fixing would be and also a couple on the south side (see photos). The pattern has been retouched over these areas.

1. View of chancel arch. Note the later fills at the centre, bottom centre and lower south side where there were probably fixings for the attachment of the rood. The much more vivid retouching on the lower north side is also visible.
2. Detail showing area of original decoration exposed beneath the later retouching.
3. Splashes of render on the wall painting
4. Paint losses on the lower south side.
5. Detail showing the decayed and pitted surface.
6. Detail showing retouching on the leaves by Randolph.
7. Detail showing the earlier decoration continuing beneath the later border.
8. Detail showing the negative image of the leaves left after paint loss.
9. Pulpit
10. Screen
11. Detail of coloured prints that have been stuck on and varnished

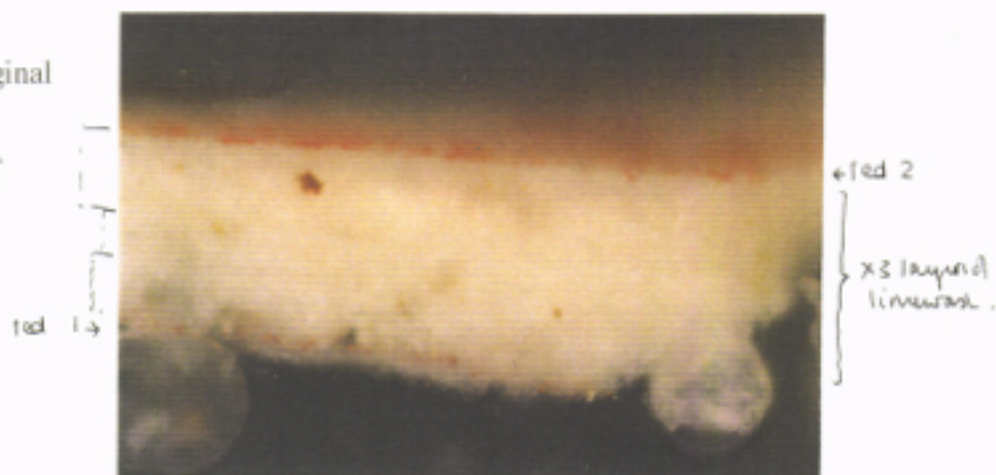
**SAMPLE 1**

Two reds are visible in the section.

The most recent decoration consists of a fairly thick layer of pure, dark red iron oxide laid on a white limewash ground.

A thin skim of an earlier red iron oxide can be seen further down the section, separated from the most recent decoration by two coats of white limewash.

Red, thought to be original decoration.

Showing two layers of red.

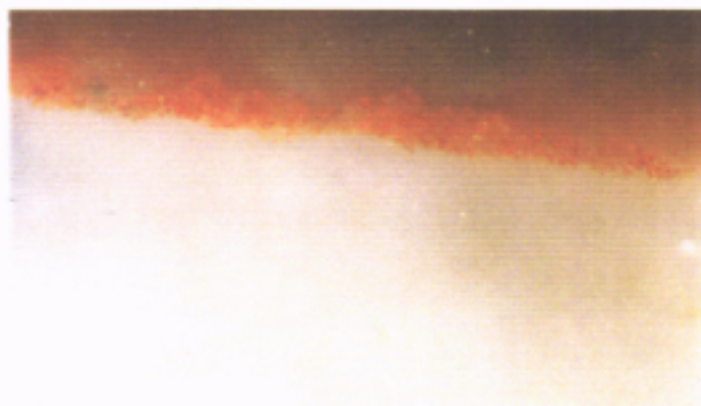
Detail of the top red

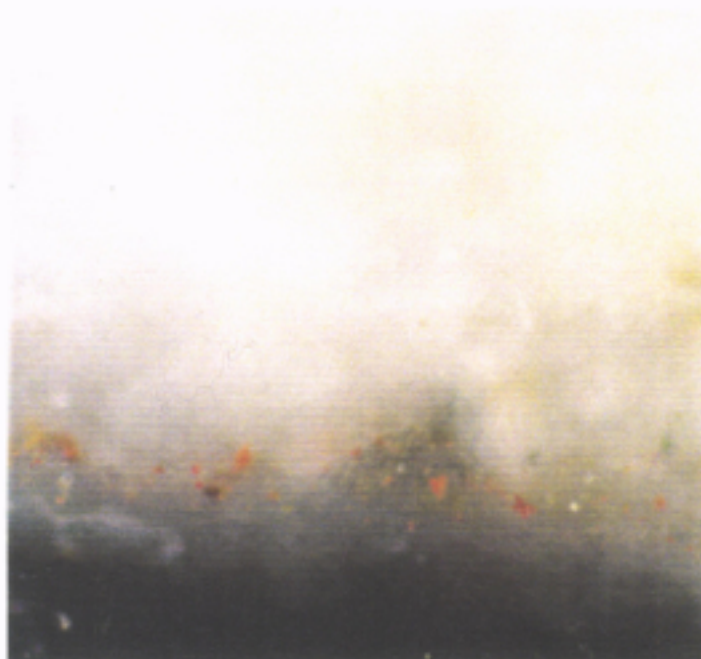
Detail of the bottom red

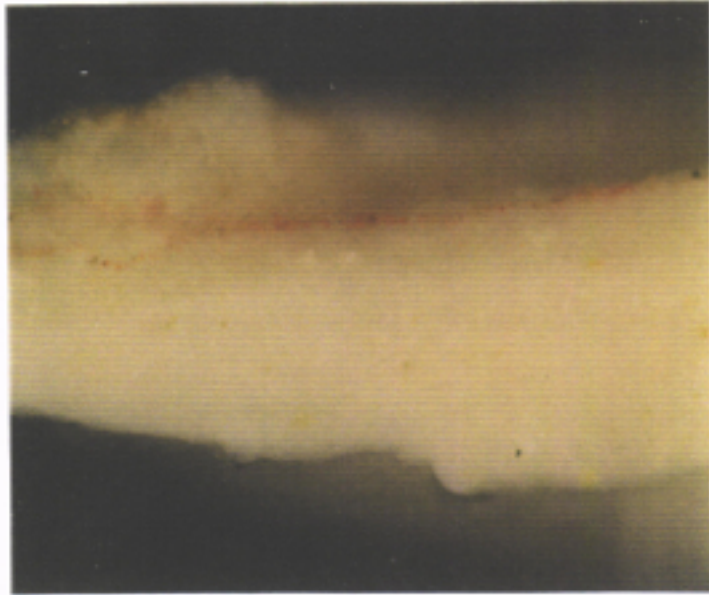
**SAMPLE 2 (i)**  
Red from an earlier layer

The most recent red is absent from these fragments, but the earlier scheme is visible in all of them, trapped between layers of white limewash.

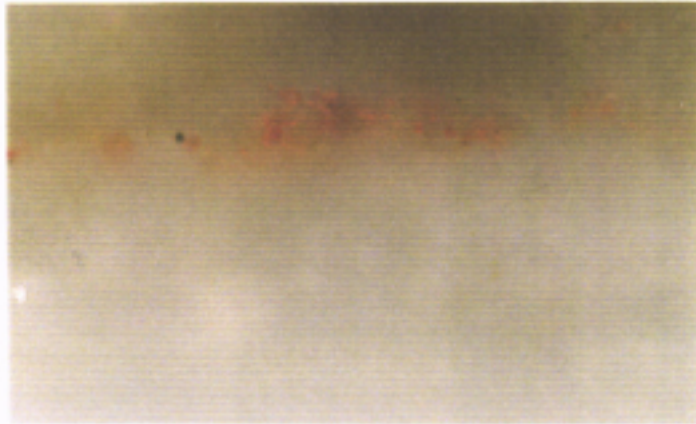
Detail of the red

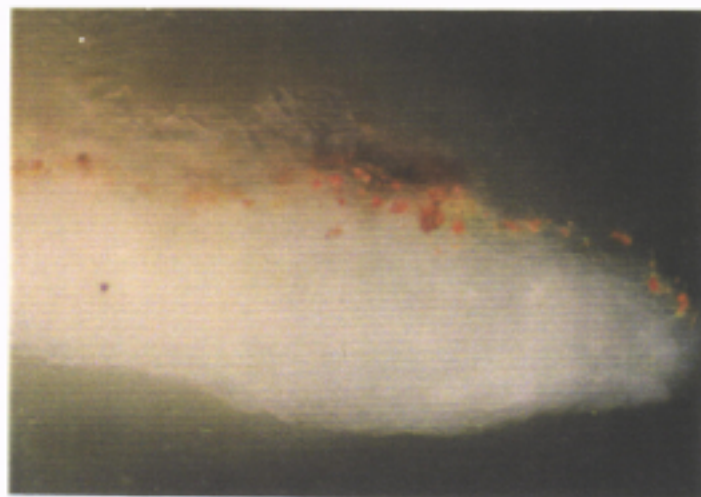
Another fragment

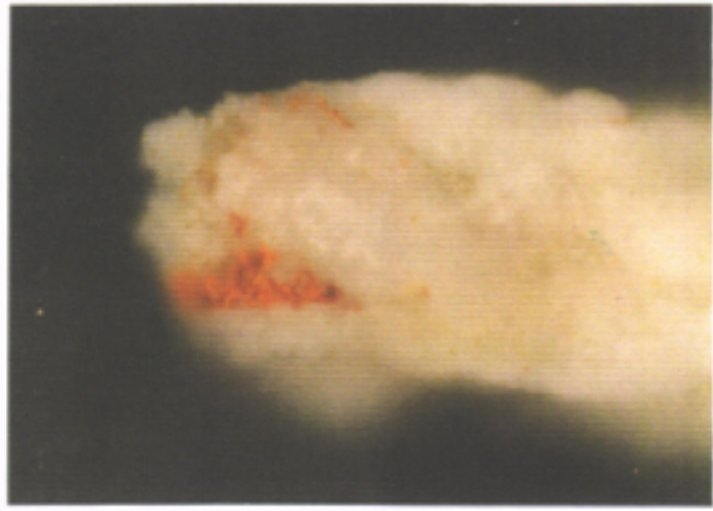
**SAMPLE 2 (ii)** - another fragment

In most of the fragments the trapped red consists of a thin line of red ochre particles, but in one there is a pocket of the red, where it can be seen to be a mixture of both red and yellow pigment, i.e. less pure than the dark red of the more recent scheme.

Red from an earlier layer

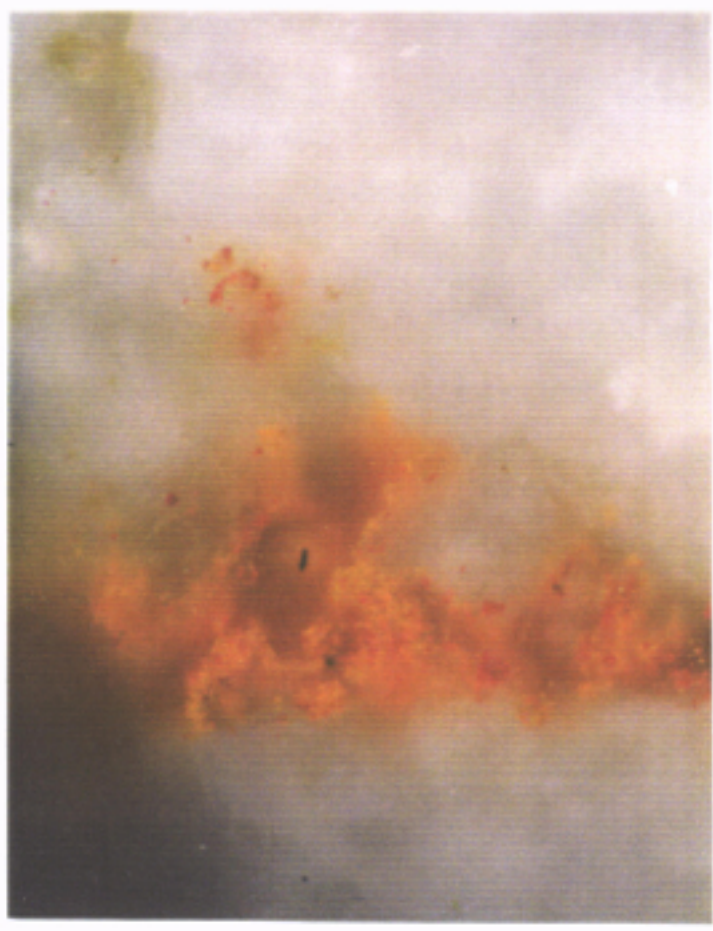
Yellow as well as red particles in the iron oxide

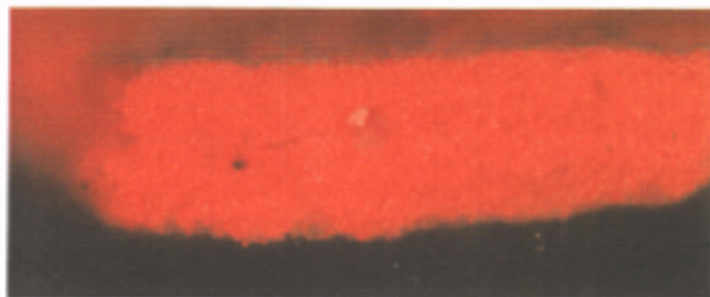
**SAMPLE 3**

The black is a discoloured vermilion resting on a white limewash ground. Only the upper surface of the red has blackened, the rest of the layer is unchanged.

'Black' paint - probably later retouching

Pure vermilion

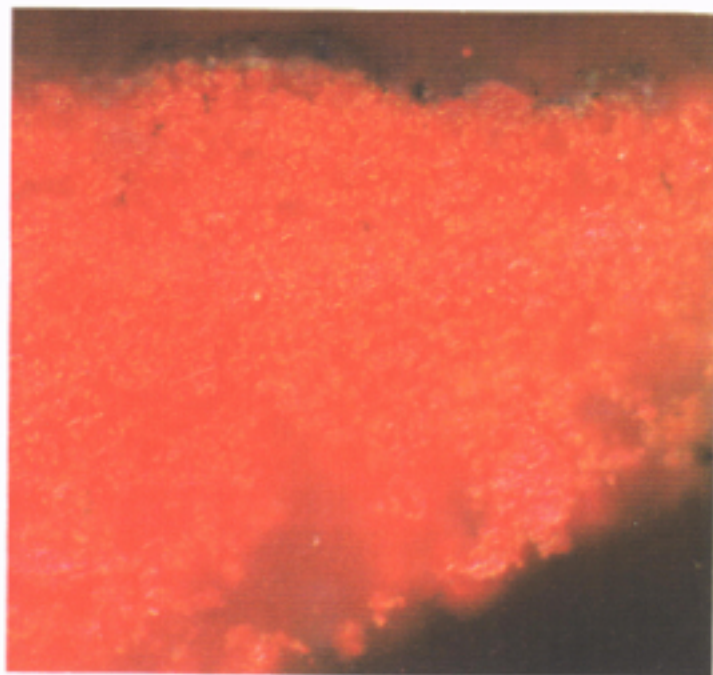
← blackened surface.

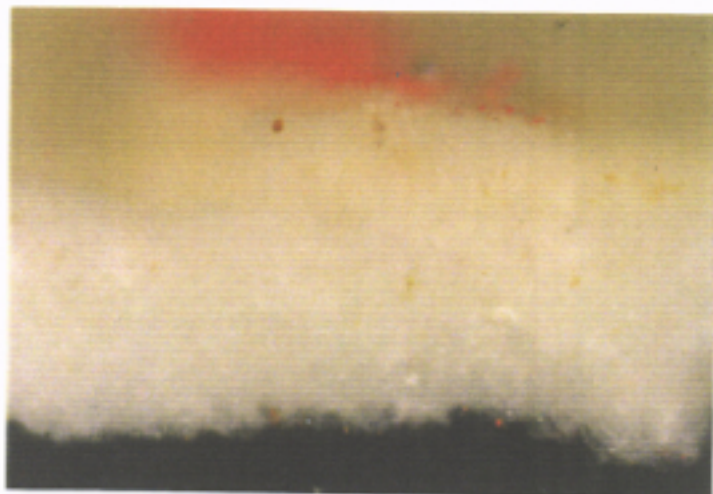
Under the limewash ground is another white limewash, but no evidence of earlier coloured paint schemes.

Two layers of limewash & trace of vermilion

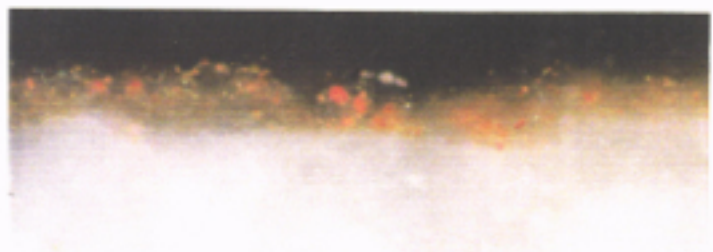
x2  
limewash

The paint is richly bound, which is probably why only the surface has blackened.
