Ringmore Church Bells: Some Historical Notes

Ringmore Church Bells

Report on the Tower & Bells of Holy Trinity, Ringmore

Date of Inspection, 5 July 1995

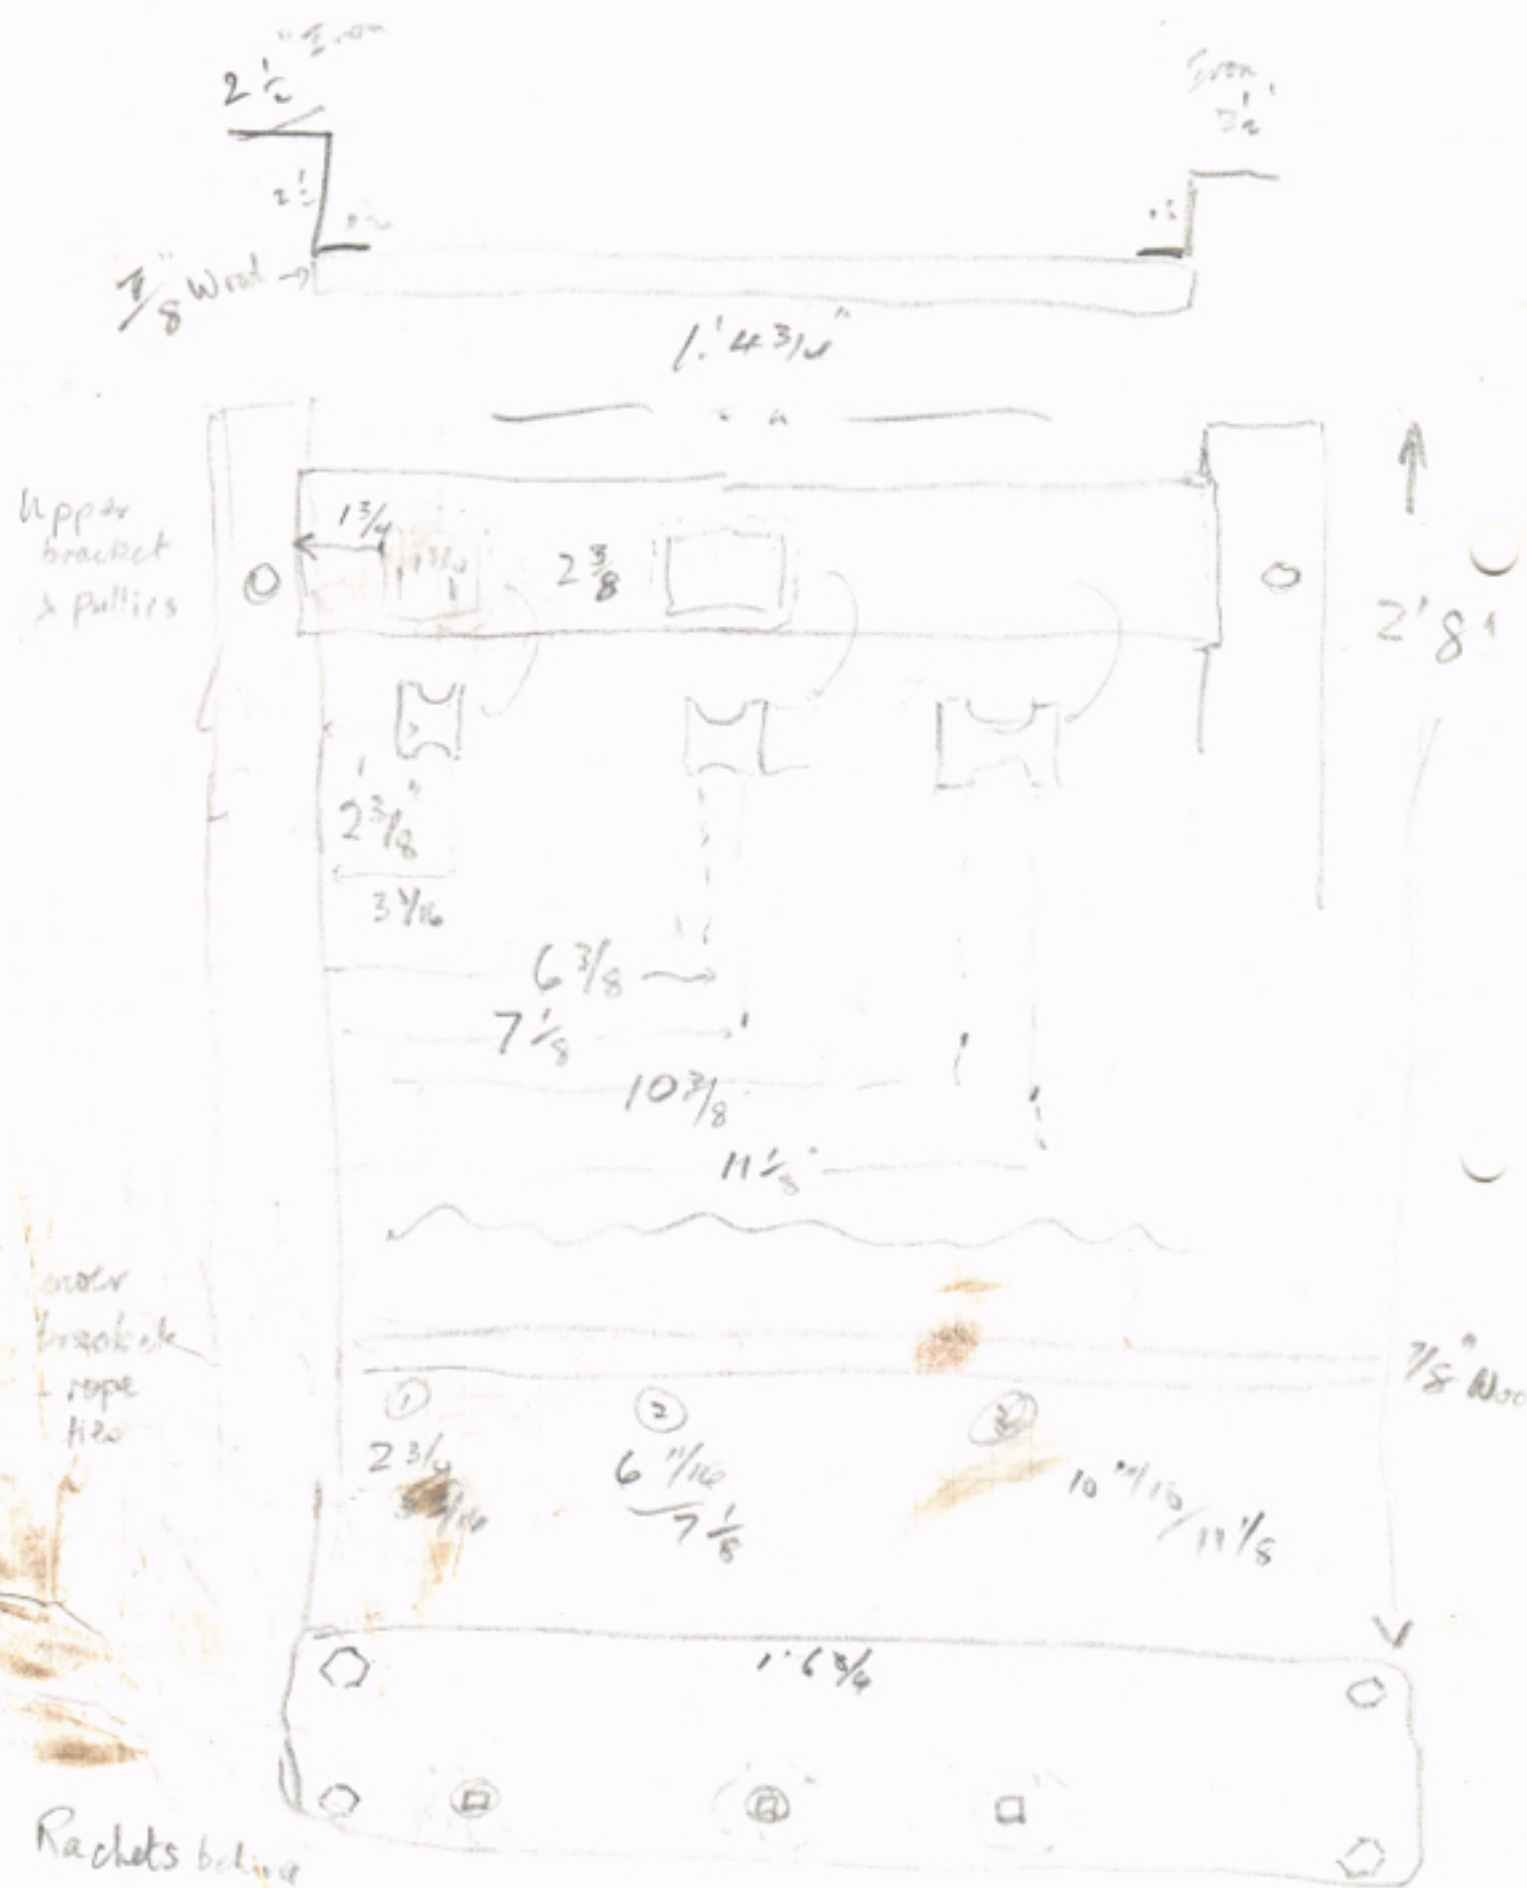
Chinning frame

Hold fasts $\frac{5}{8}$ " bar flathead
to $1\frac{3}{4}$ "

Beam $3\frac{1}{2}$ " x 2"
