Colonel Grimshaw
Middle Manor, Ringmore,
KINGSBRIDGE

HIGHWAY MONUMENTS SURVEY

PARISH OF RINGMORE

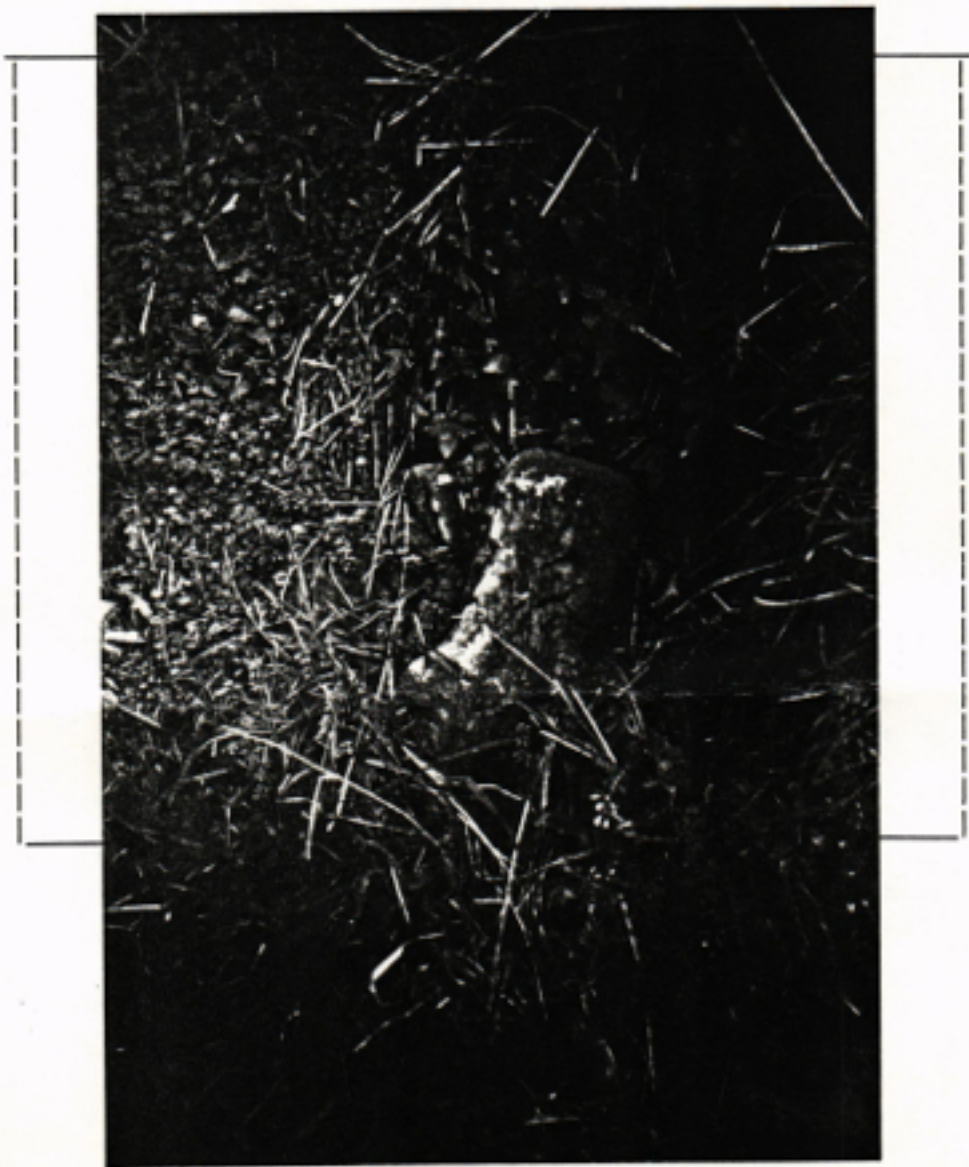
Roll 3
R-9207
no 8

C 252 13090 277.7 L E BOUNDARY STONE

General Condition : Fair

Chipped off at front.

Needs to be set back further from road.

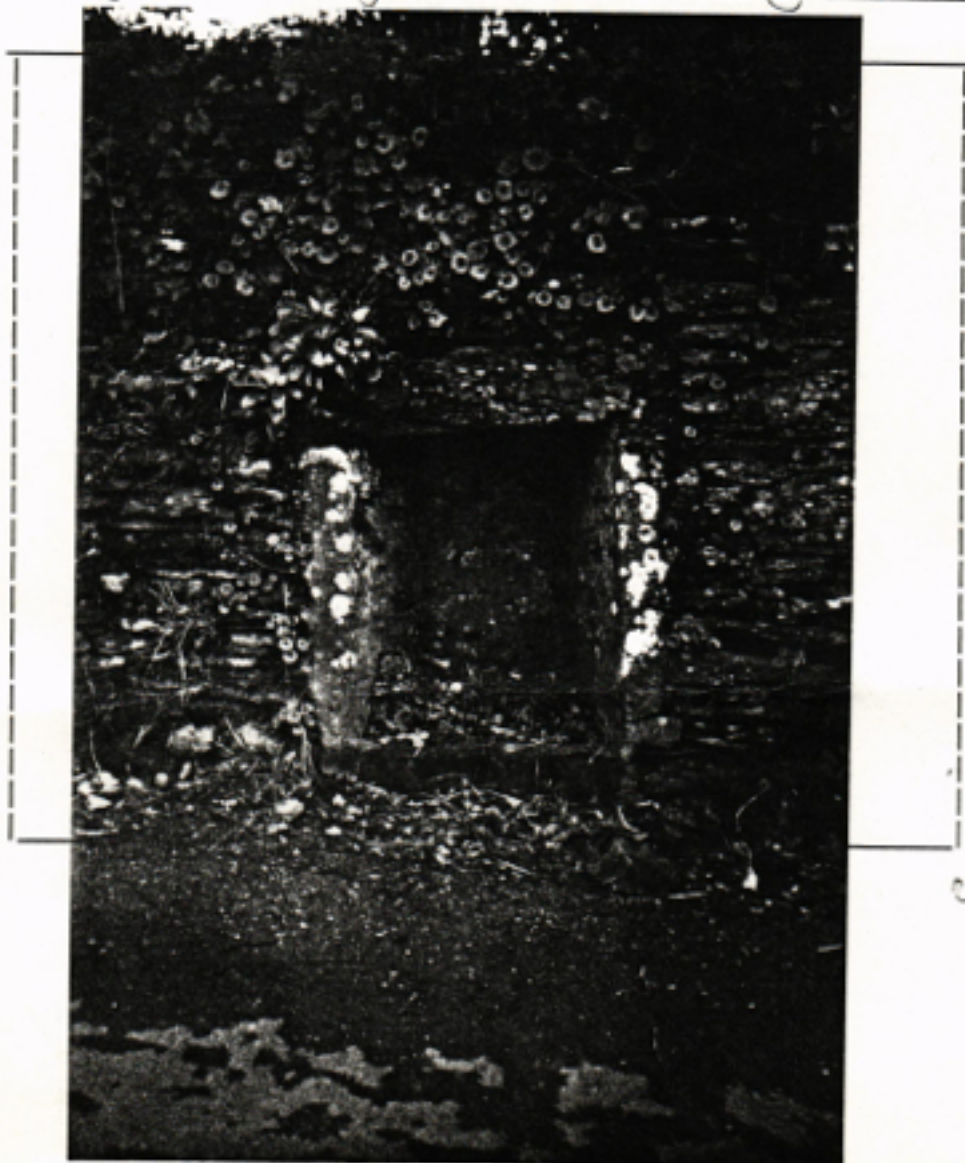
Cell 2 (R+929)
no. 17.

Drain, part of system
from 9 / Now blocked
up. Used for
depositing slops.

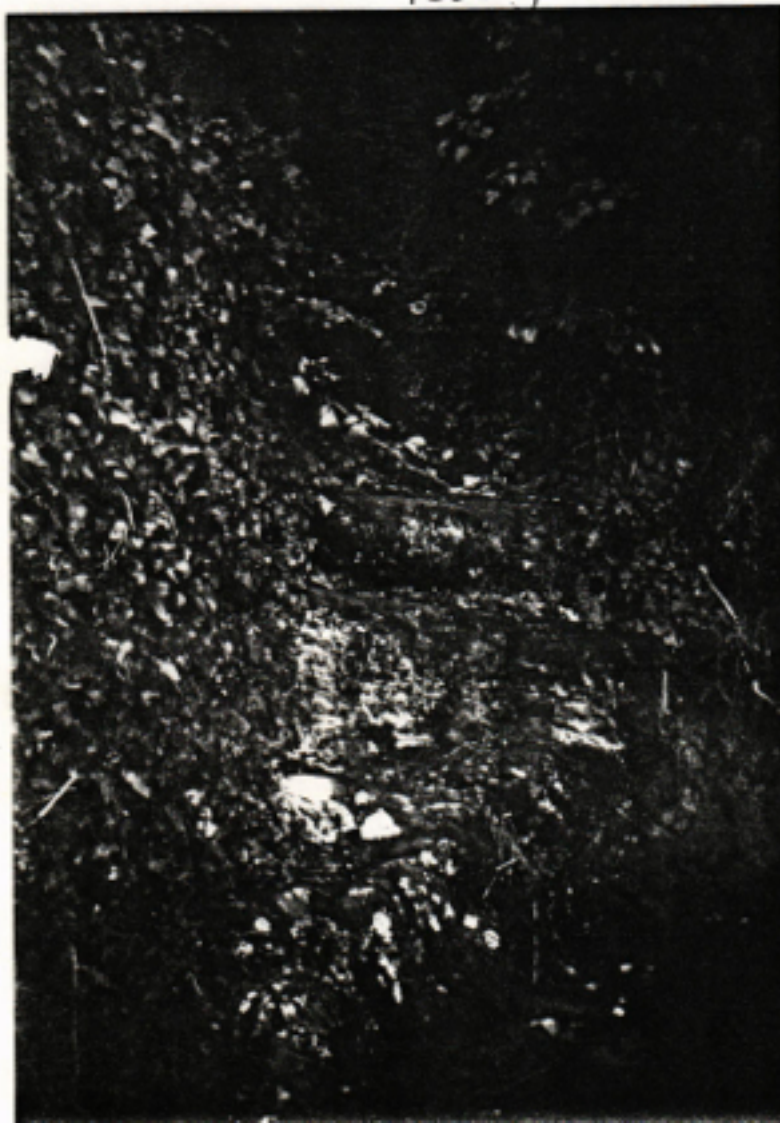
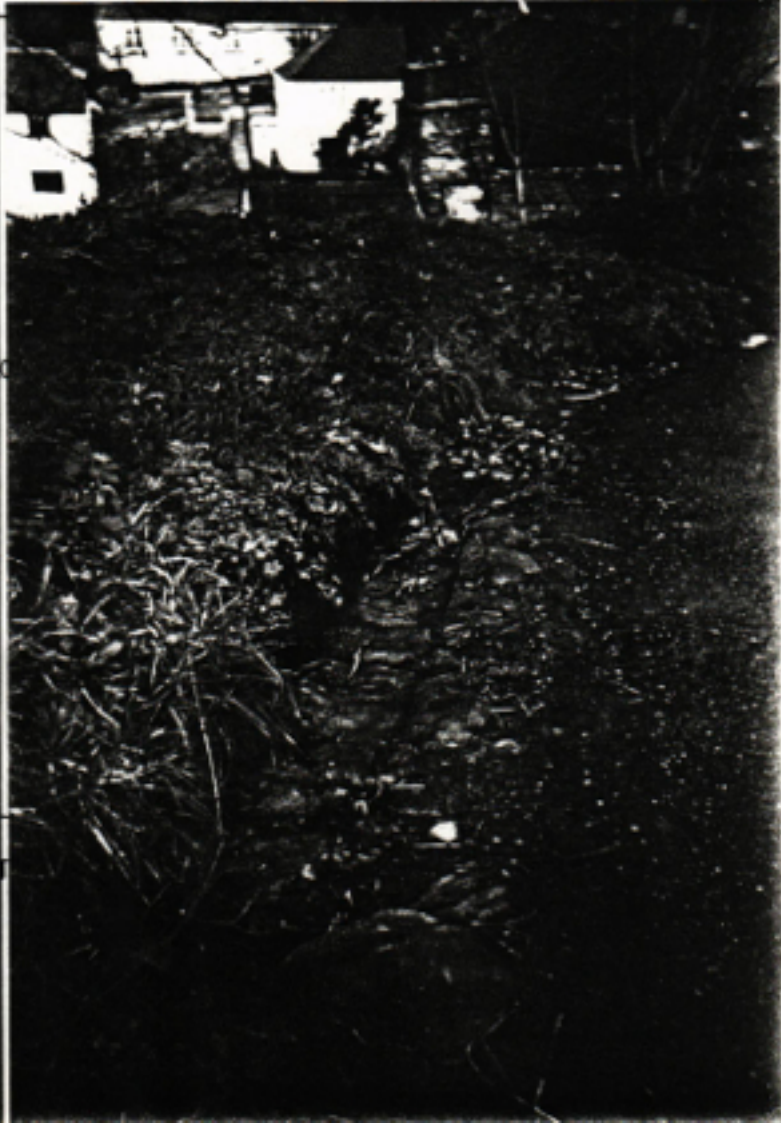
Roll 2
(2492)
no. 4.

Class	Road Section	Chainage	Position 1	Position 2	Description
Z	3011	13020	64.3 97.1	Both edges	Remnant of once exposed rocky surface + steps cut out of rock at 97.1.

Many requests from P.C. to re-expose rocky surface.

Highly recommended as above.

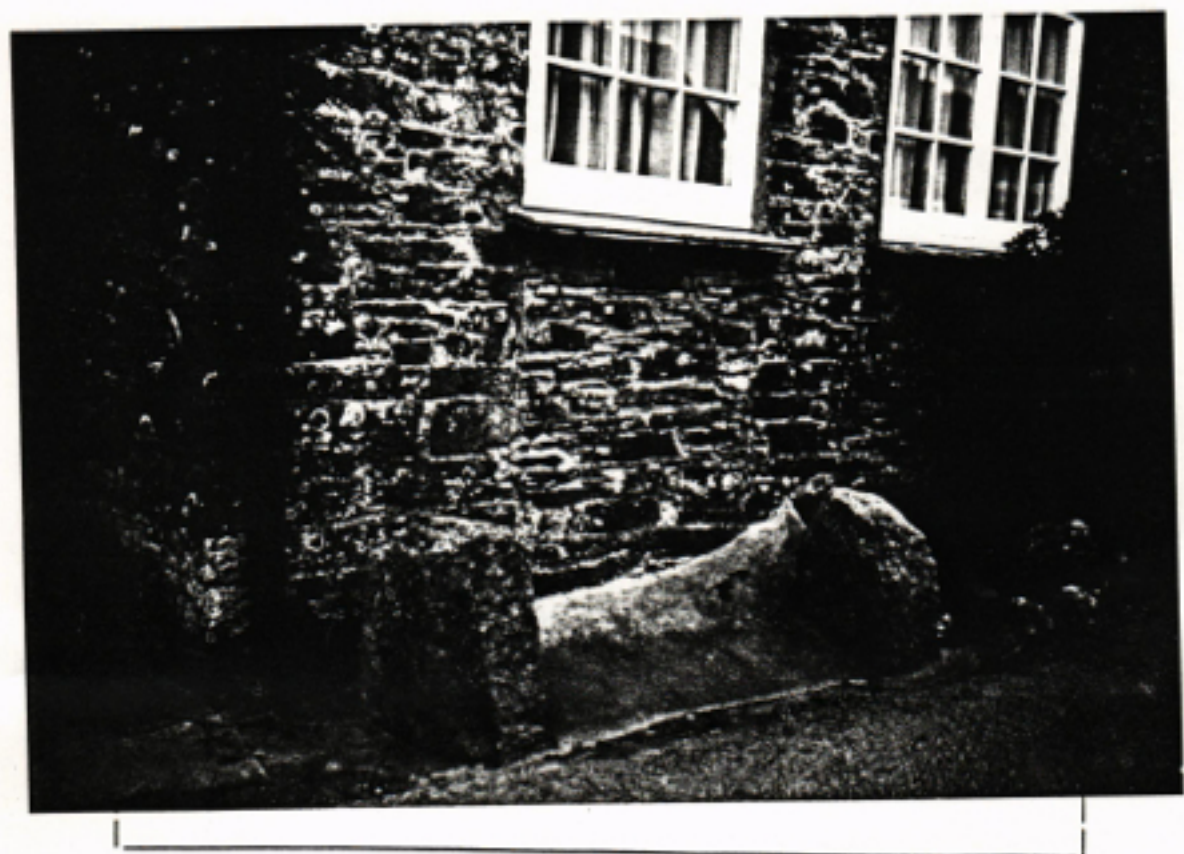
Roll 14 no: 10

Class	Road Section	Chainage	Position 1	Position 2	Description
C	81	13040	96.4 R	Wall	granite posts marking site of former porch on dwelling once known as Outer Mongolia. (See attached letter)
