Ringmore Church Bells: Some Historical Notes

Ringmore Church Bells

Report on the Tower & Bells of Holy Trinity, Ringmore

Date of Inspection, 5 July 1995

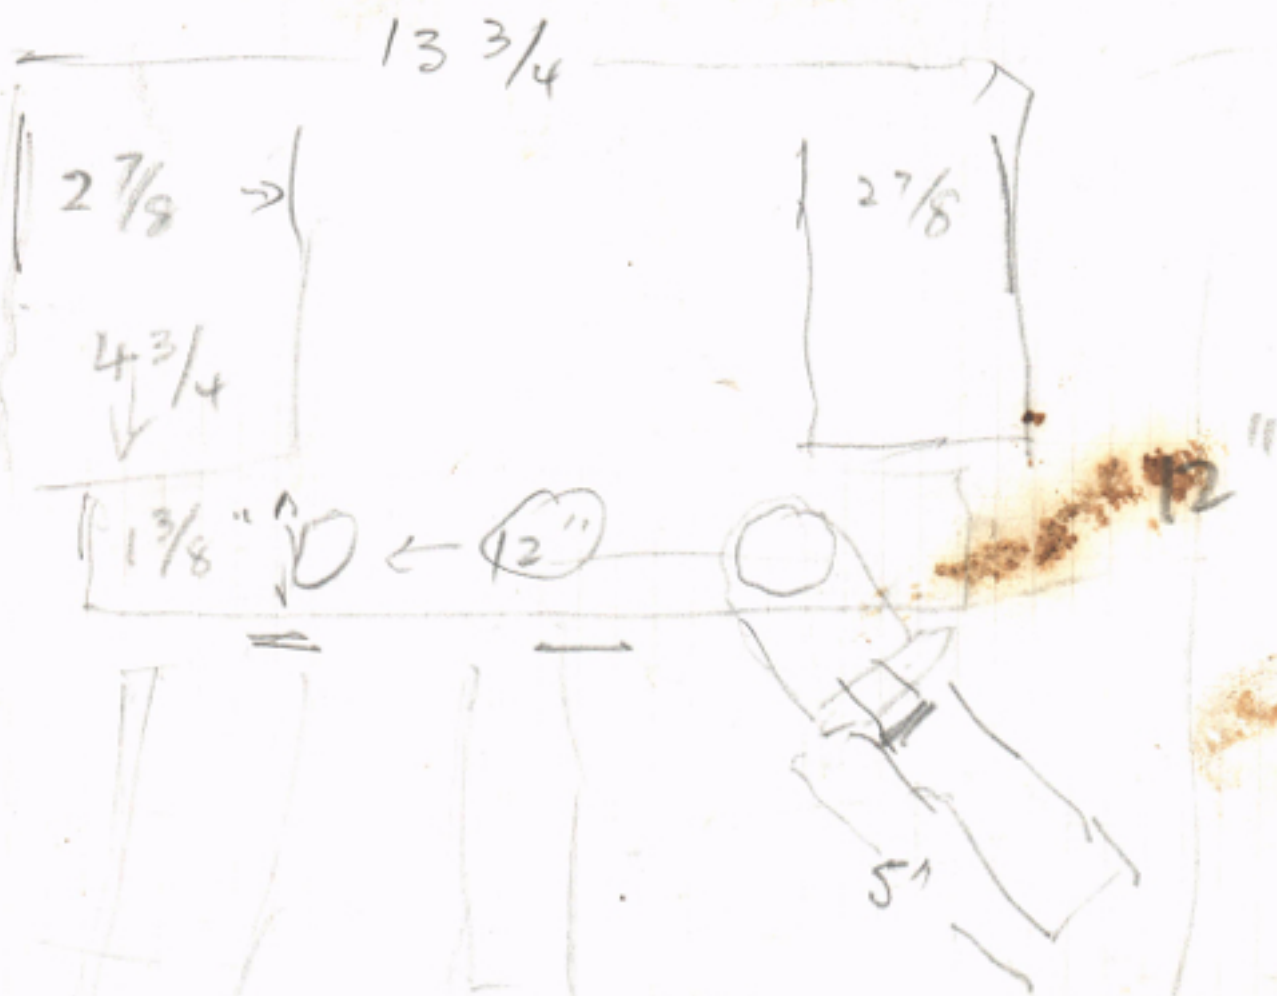
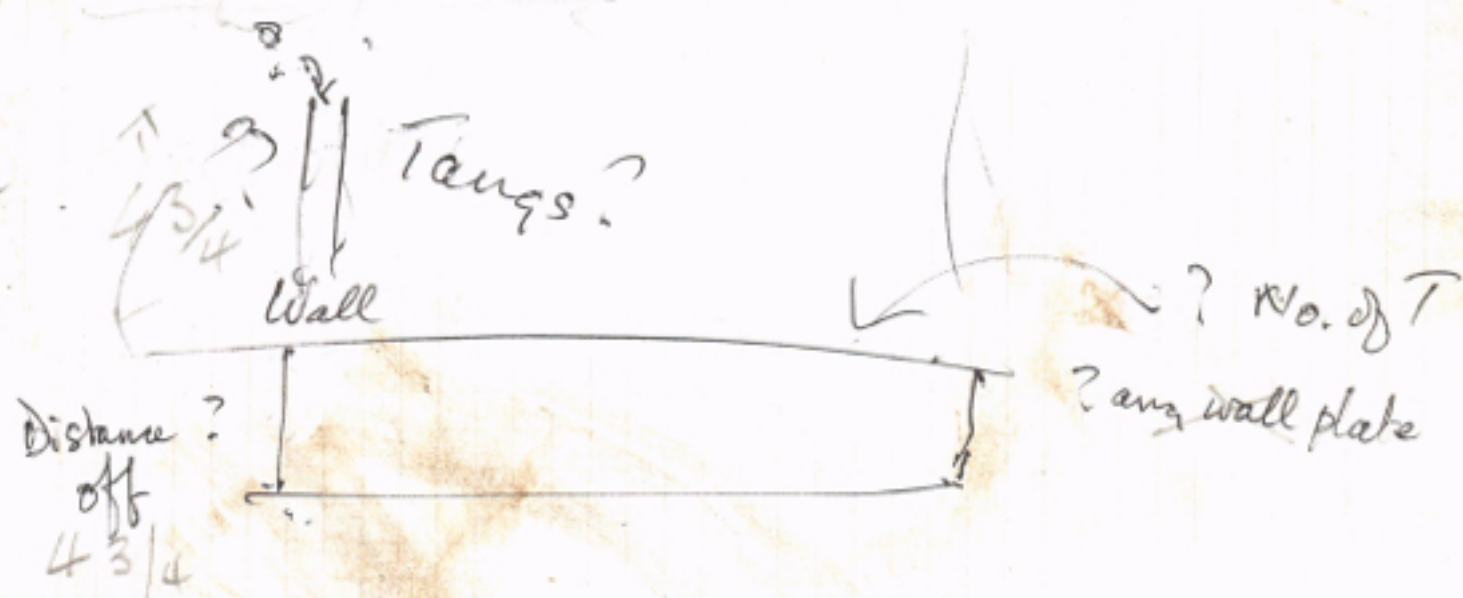
The steelwork has all suffered from the weather and proximity to the sea, which always increases corrosion in steel. The ends of the girders, where they meet the walls, are laminating and the expansion is splitting the stonework round them, while the rest of the steel is showing blistering of the paint as rust pockets form underneath it.

The bell-bolts, and probably the centre-bolts too, are rusting severely, and although there is probably ample reserve strength in them they are now expanding so that they fit very tightly in their holes and could at any time split the heads of the bells. The clappers and fittings are rusty but serviceable; the clappers of the Treble and Tenor have lost their "trigger-action" property and the heads of the clappers can be held against the bells. This is probably caused by wear. The chiming panel downstairs has ratchet adjusters for the ropes, but these have all siezed up solid, and one of them has had its square sheared off in an attempt to move it. The ropes can be adjusted in the ordinary way, but less easily.

Recommendations. The urgent need is to prevent rust from doing any more damage. The steelwork of the frame should be cleaned off and painted with rust-preventing paint as quickly and as thoroughly as possible.

The bell-bolts should be drawn, and replaced with new ones, either hot-dip galvanized or for preference (though much more costly) stainless steel.
