QUINQUENNIAL INSPECTION

CHURCH OF ALL HALLOWS, RINGMORE, DEVON

DATE OF INSPECTION 22ND SEPTEMBER 1999

MSW Conservation
Chartered Architects & Surveyors
PO Box 27
Lifton
Devon PL16 0YD

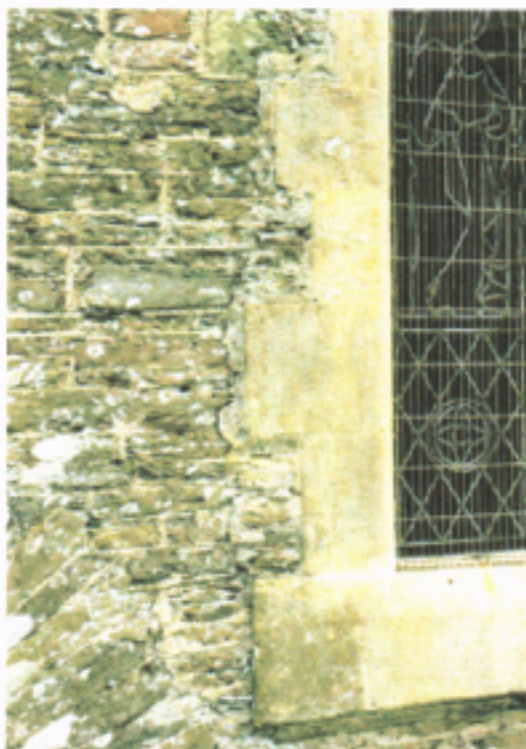
South wall - east end

Bath stone dressing in good condition. Water penetration to the interior of the church noted. Pointing between window dressing and masonry wall requires attention see south wall re-pointing page 6. Window grille rusting and may need replacing.
