## **All Hallows Church, Ringmore, Devon**

**Survey of the Wall Painting on the West Face of the  
Chancel arch  
and polychrome on the pulpit and screen**

**October 2003**

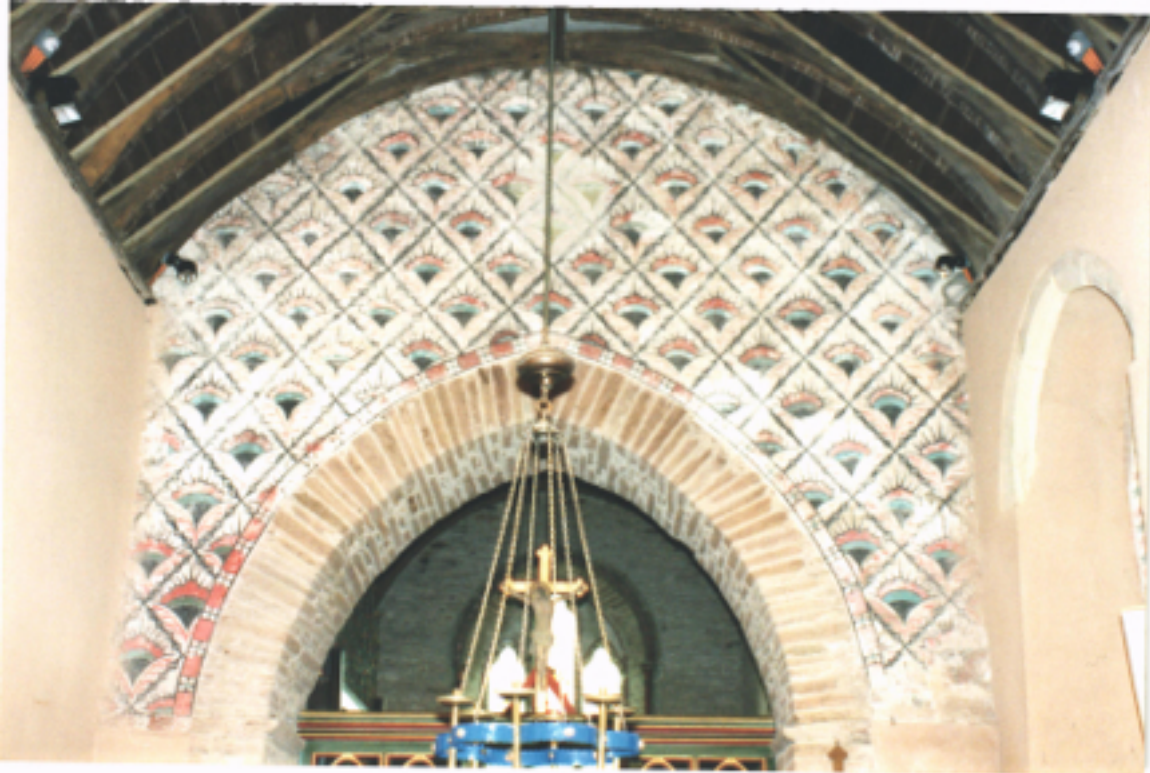
1. View of chancel arch. Note the later fills at the centre, bottom centre and lower south side where there were probably fixings for the attachment of the rood. The much more vivid retouching on the lower north side is also visible.
2. Detail showing area of original decoration exposed beneath the later retouching.
3. Splashes of render on the wall painting
4. Paint losses on the lower south side.
5. Detail showing the decayed and pitted surface.
6. Detail showing retouching on the leaves by Randolph.
7. Detail showing the earlier decoration continuing beneath the later border.
8. Detail showing the negative image of the leaves left after paint loss.
9. Pulpit
10. Screen
11. Detail of coloured prints that have been stuck on and varnished

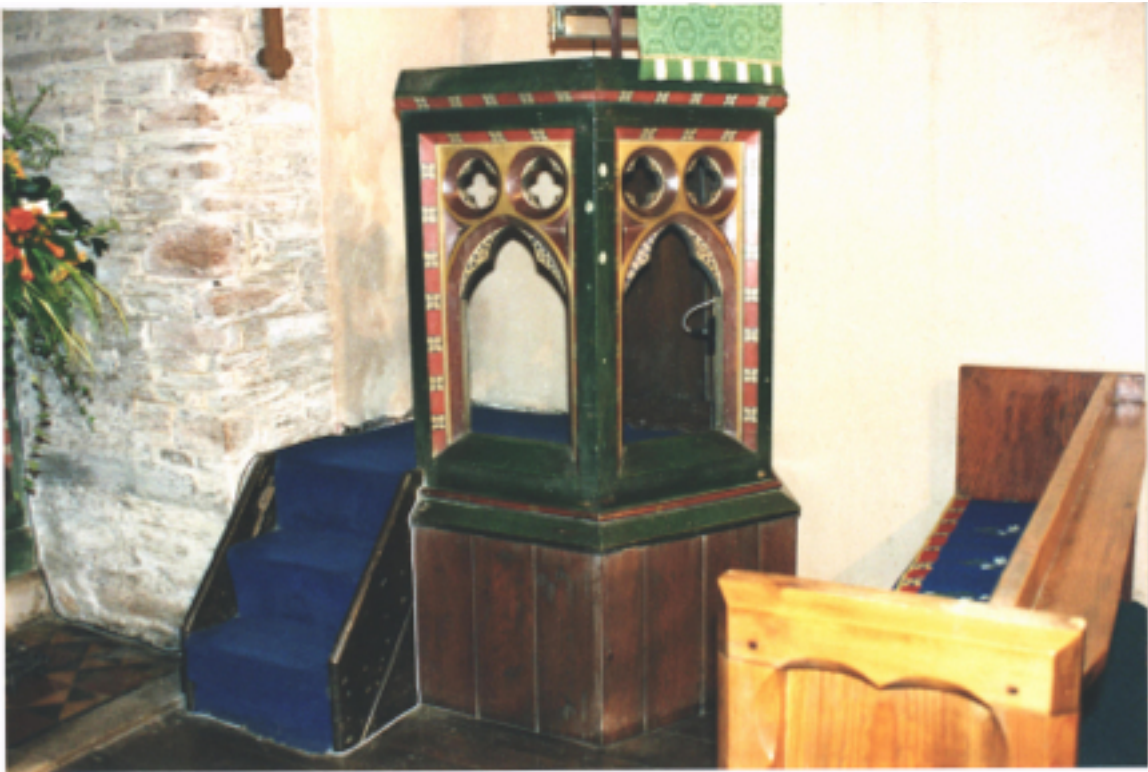
Both the screen and pulpit are painted and gilded with similar colours to those in the wall painting. The paint is a strong oil and has suffered very little damage.
