Colonel Grimshaw
Middle Manor, Ringmore,
KINGSBRIDGE

HIGHWAY MONUMENTS SURVEY

PARISH OF RINGMORE

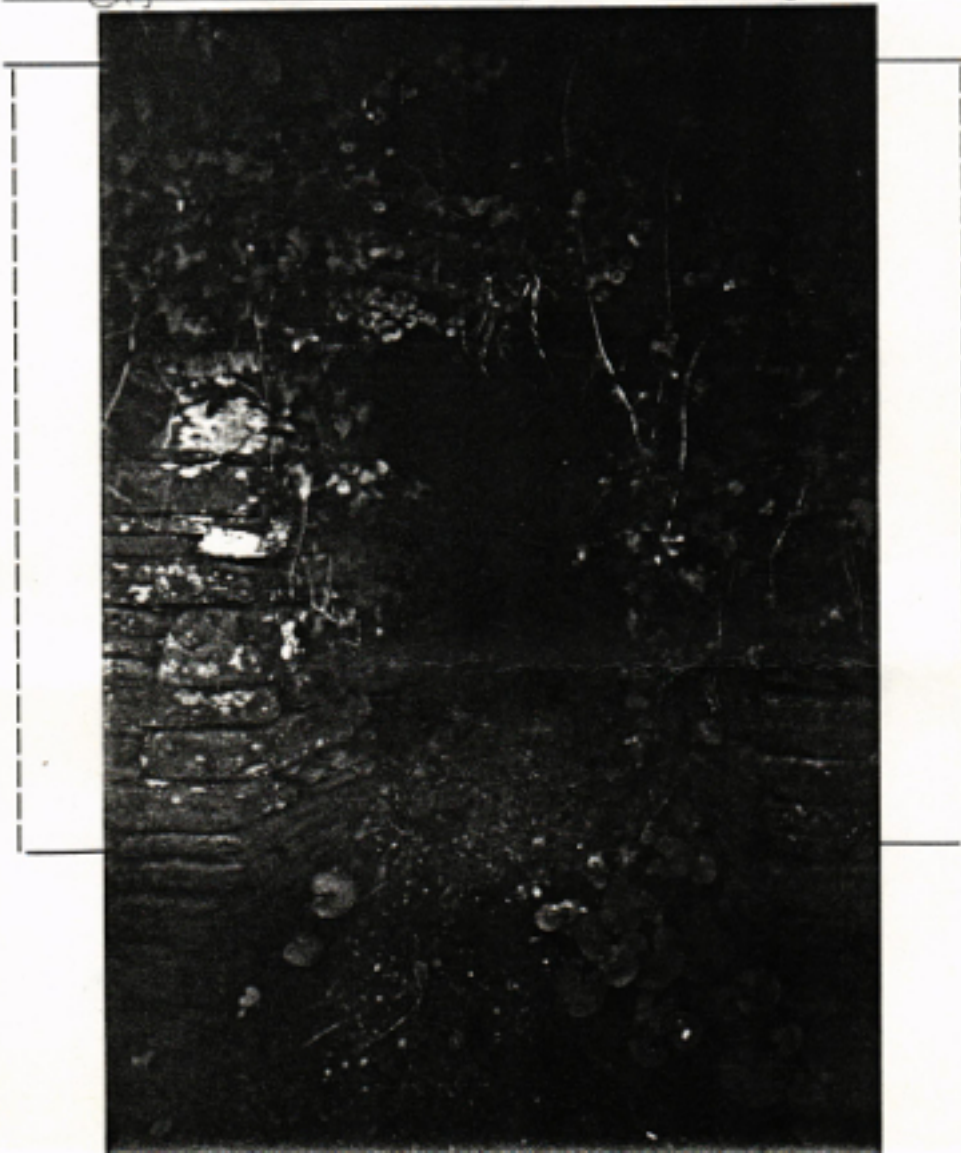
Roll 2 (R4925)
no. 12

Class	Road Section	Chainage	Position 1	Position 2	Description
Z	3026	13010	24.0	R E	UNIDENTIFIABLE Drain covered over by two rocks

General Condition : Good

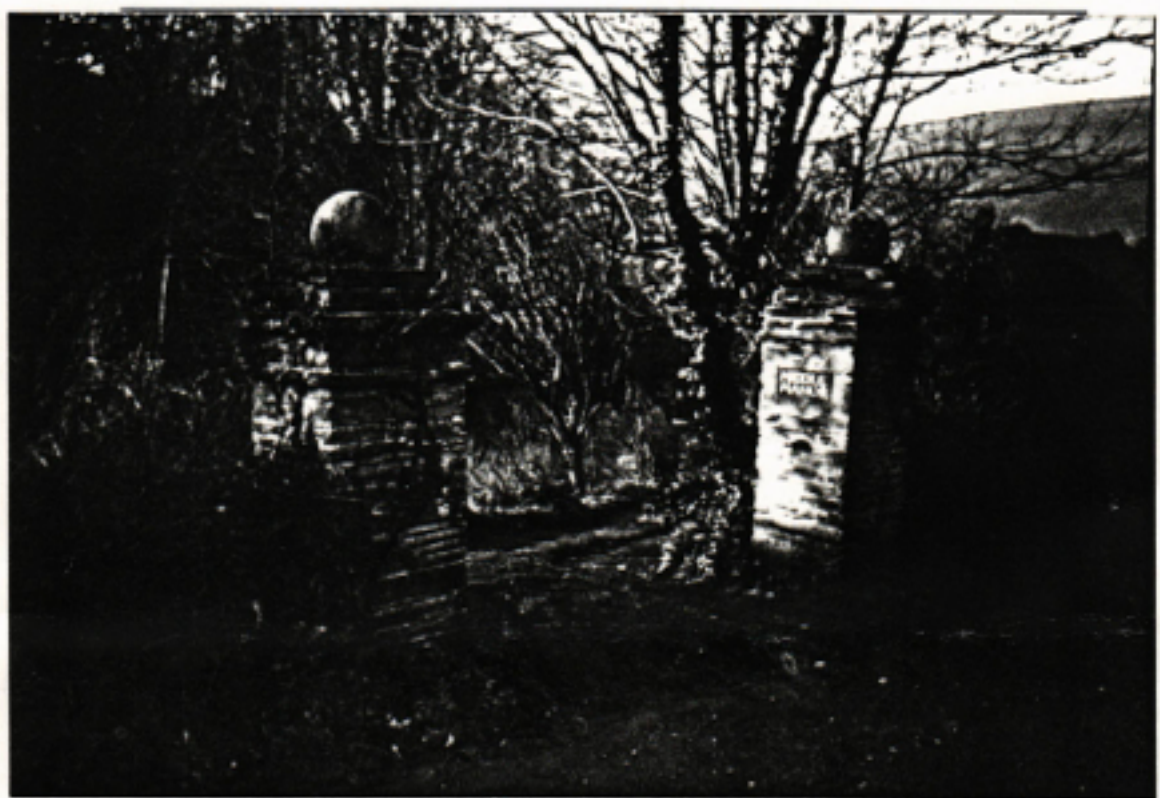
Class	Road	Section	Chainage	Position 1	Position 2	Description
Z	3026	13010	237.7	L	E	GATE POSTS

General Condition : Fair

Maintenance / Enhancement Proposals :
Top slabs could be straightened.
